Laboratory #: 592426-11
Report Date: November 21, 2011
Received Date: November 14, 2011

TEST REPORT

RE: EVALUATION OF "SKRAPR" PERFORMANCE ON STOVETOP UNDER BOTH DRY AND WET CONDITIONS USING VARIOUS WEIGHTS TO DETERMINE PRESENCE OF SURFACE ABRASIONS

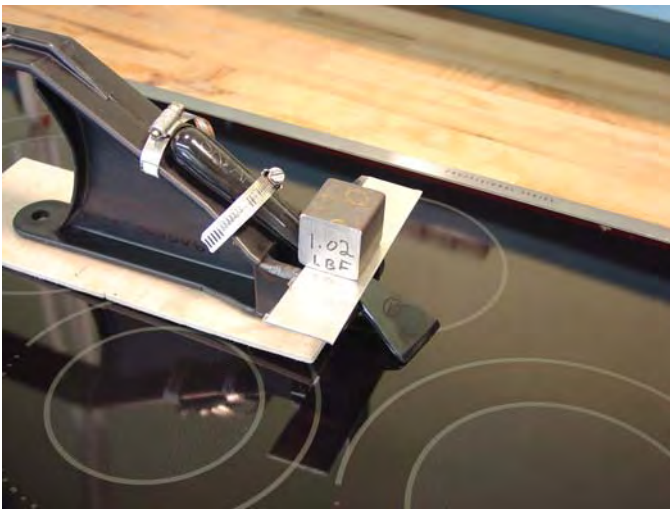
Photo #1 – View of 1.28-lb applied to blade.

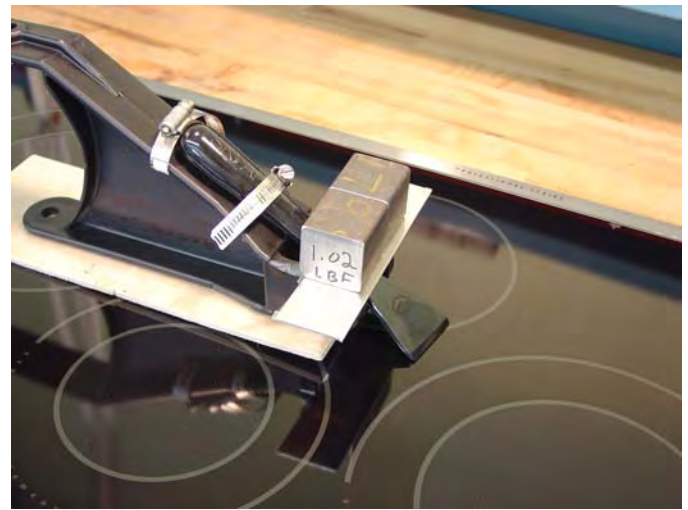
Photo #2 – View of 2.08-lb applied to blade.

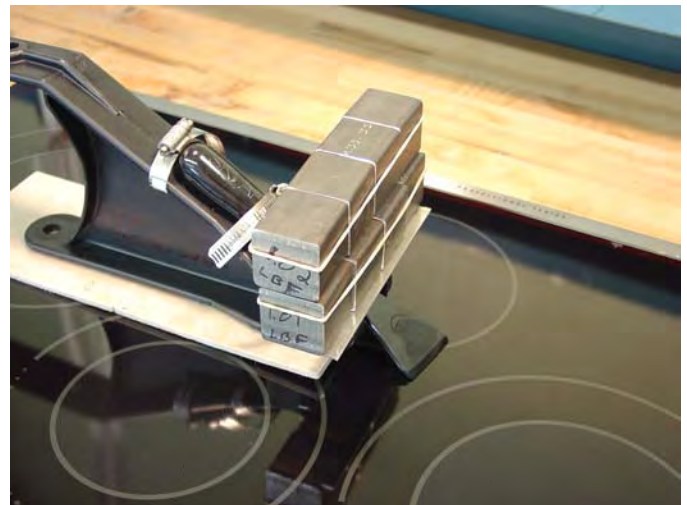
Photo #8 – View of 6.88-lb applied to blade.

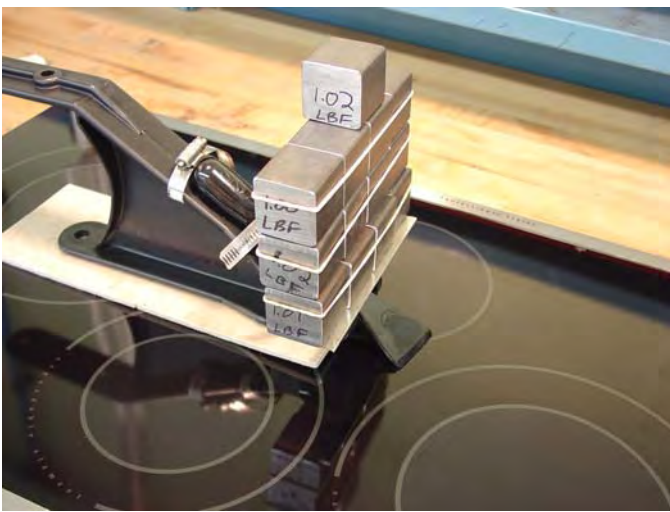
Photo #13 – View of 10.88-lb applied to blade.

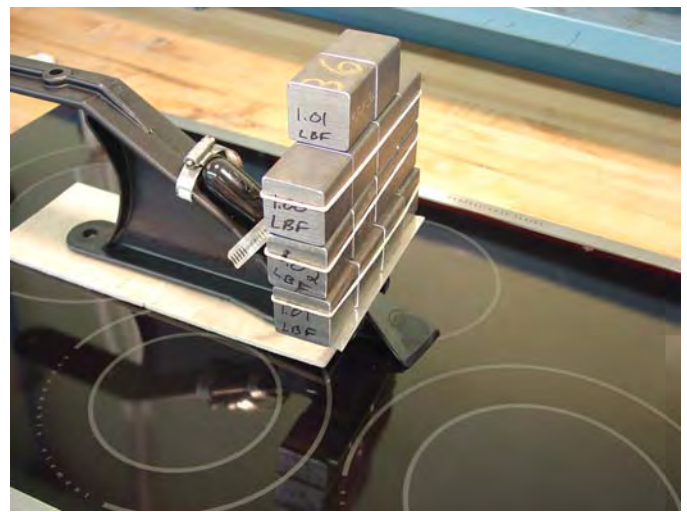
Photo #14 – View of 11.68-lb applied to blade.

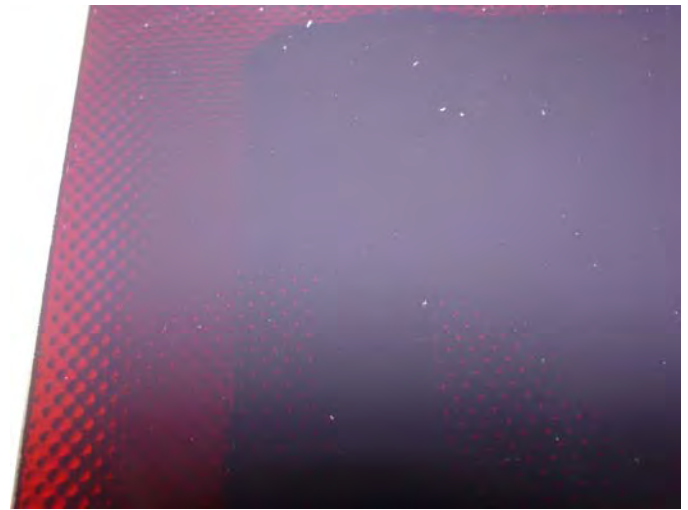
There was no visible evidence of any surface abrasions on the cooktop before or after each trial under both dry and wet conditions.

Photo #19 – View of cooktop after 1.28-lb was applied to the dry surface.

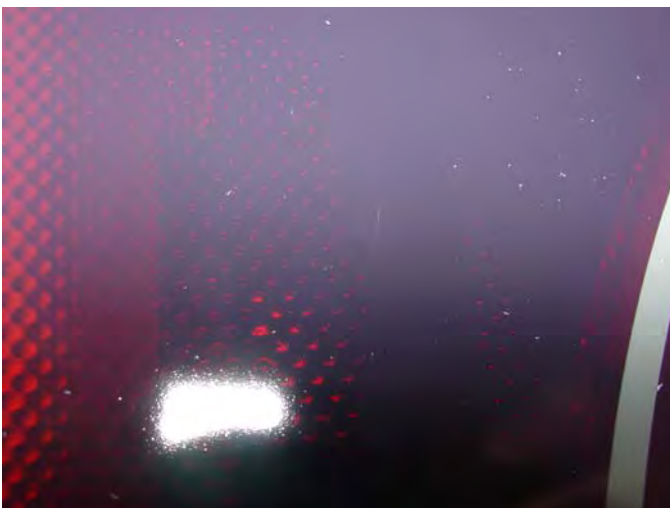
Photo #20 – View of cooktop before 1.28-lb was applied to the wet surface.

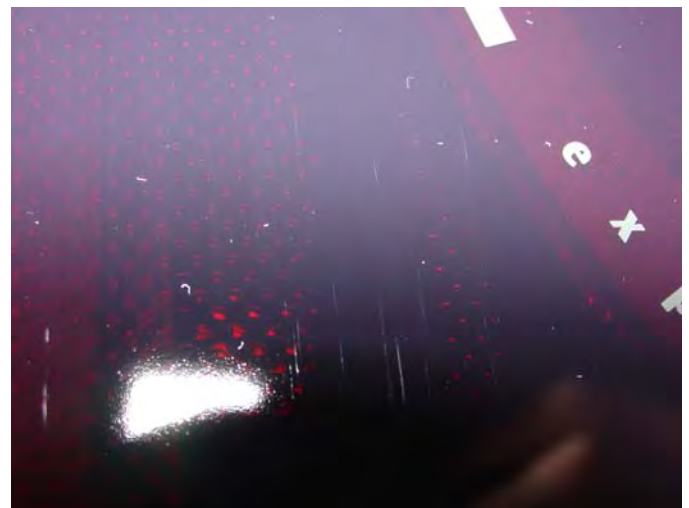
Photo #25 – View of cooktop after 2.08-lb was applied to the wet surface.

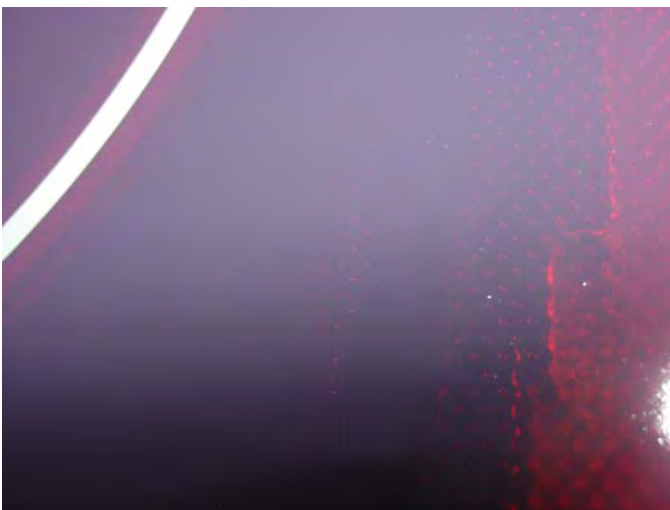
Photo #82 – View of cooktop before 14.88-lb was applied to the dry surface.

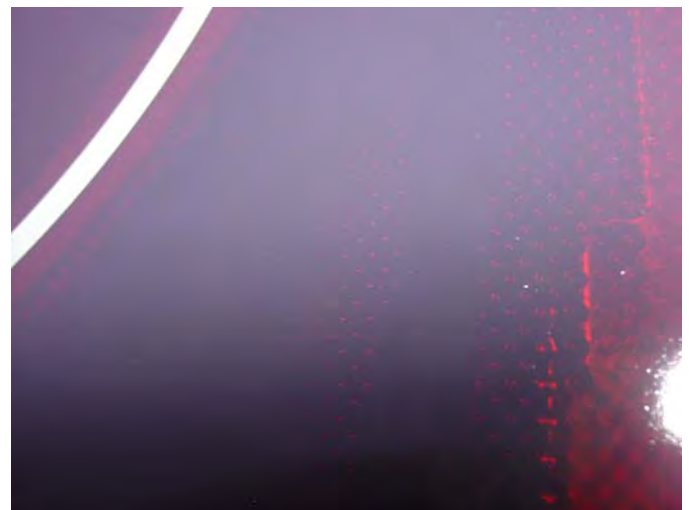
Photo #83 – View of cooktop after 14.88-lb was applied to the dry surface.
